Beechcraft 1900C Vertical Impact Test

Robert J. Mc Guire and Dr. Tong Vu
Federal Aviation Administration

ABSTRACT

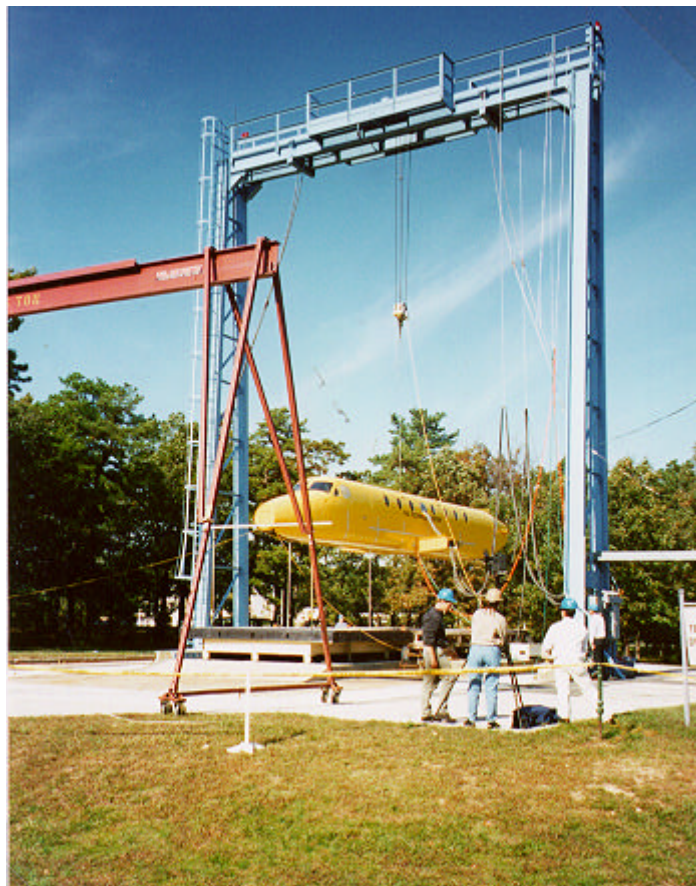
FIGURE 1. DROP TEST FACILITY

The Technical Center drop test facility, shown in figure 1, is comprised of two 50-foot vertical steel towers connected at the tops by a horizontal platform. An electrically powered winch, mounted on the platform, is used to raise or lower the test article and is controlled from the base of one of the tower legs. The current lifting capacity of the winch is 13,600 pounds. Attached to the winch is a reeved hoisting cable which is used to raise the test article. A sheave block assembly hanging from the free end of the reeved cable is engaged to a solenoid operated release hook. The release hook is connected to the airframe by a cable/turnbuckle assembly with hooks bolted to the fuselage section at four locations. Located below the winch cable assembly and between the tower legs is a 15- by 36-foot wooden platform which rests upon I-beams and is supported by 12 independent load cells.

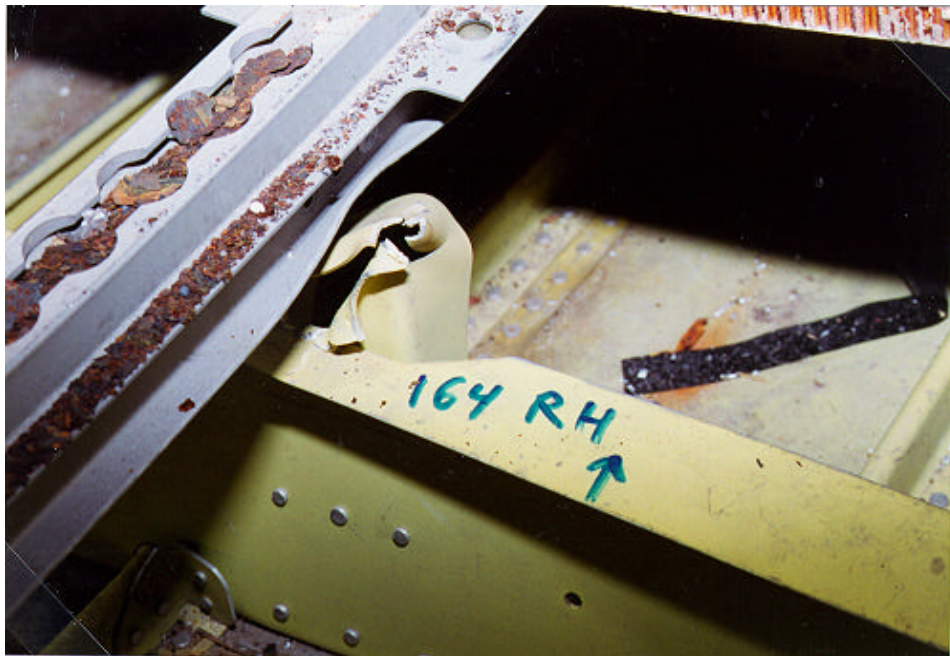
FIGURE 6. UNDERFLOOR BUCKLING RIGHT-HAND SIDE AFTER IMPACT

INTERNAL. The structural deformation experienced on the inside of the test article was minimal. The seat tracks remained intact and in place. Minor buckling was seen along the fuselage underfloor and side walls (see figure 6).

The still photographs in this report were taken with a 35-mm camera both prior to and following the drop test. Examples of these photographs are seen in figures 5 through 7.
